KINGSLEY BROOK RESERVOIR DAM

MADISON COUNTY, NEW YORK
INVENTORY No. NY. 353

PHASE I INSPECTION REPORT NATIONAL DAM SAFETY PROGRAM

NEW YORK DISTRICT, CORPS OF ENGINEERS
JUNE 1981

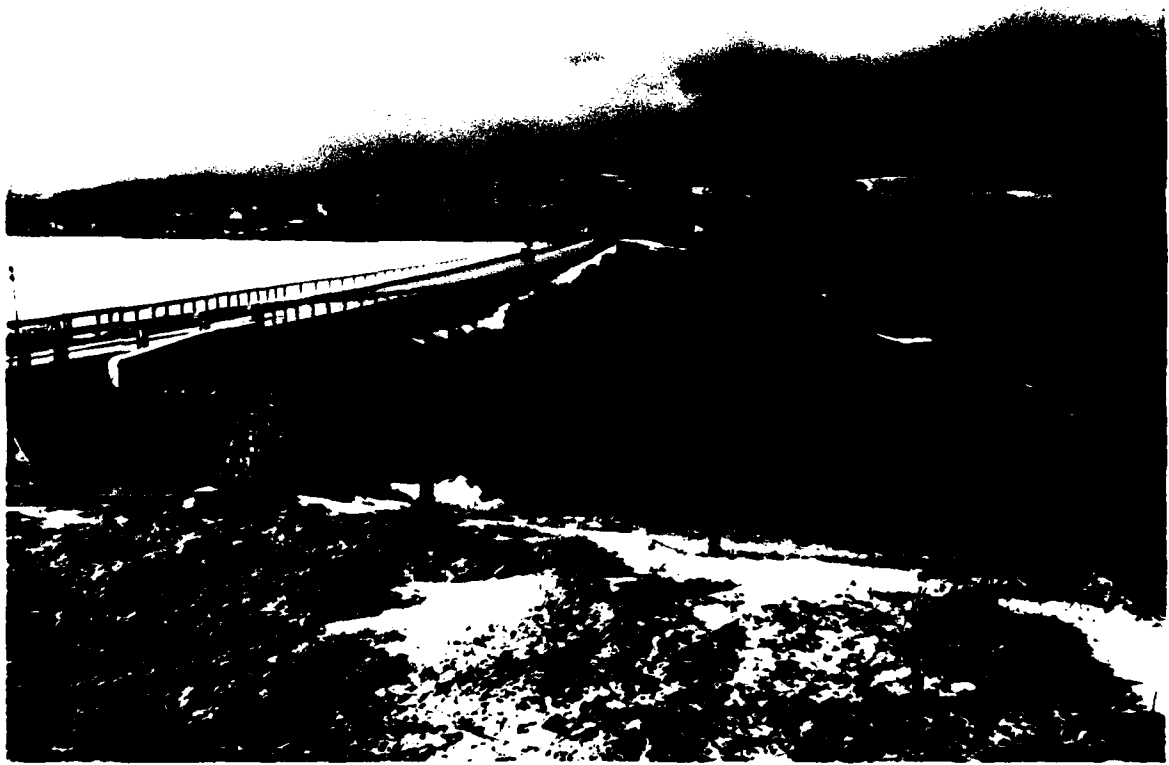
PHOTO #1: Overview of
Kingsley Brook Reservoir Dam
Inventory No. NY 353

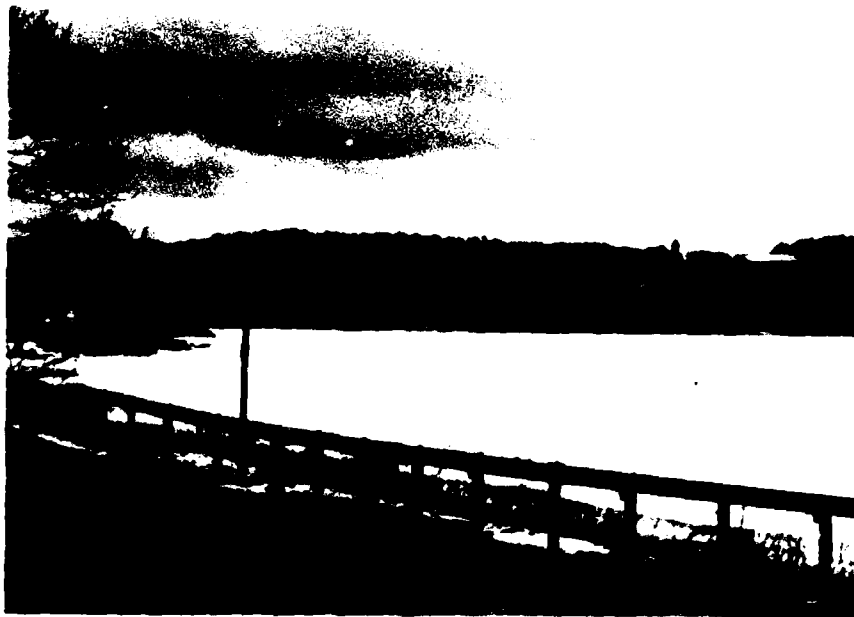
PHOTO #2: Overview of impoundment

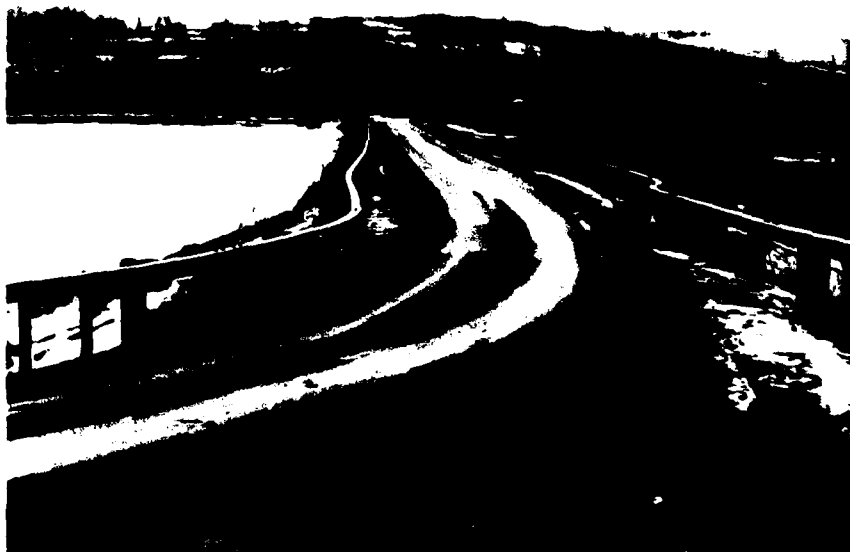
The earthfill embankment of the dam is generally in fair condition (See Photos No. 4, 5, 6 and 7). Reservoir Road runs along the dam crest which is in good condition (See Photo No. 3). There was no visible evidence of lateral movement, settlement, erosion or other serious defects. However, there is concern relative to seepage conditions at the downstream toe of slope.

PHOTO #3: Crest of dam looking toward left abutment

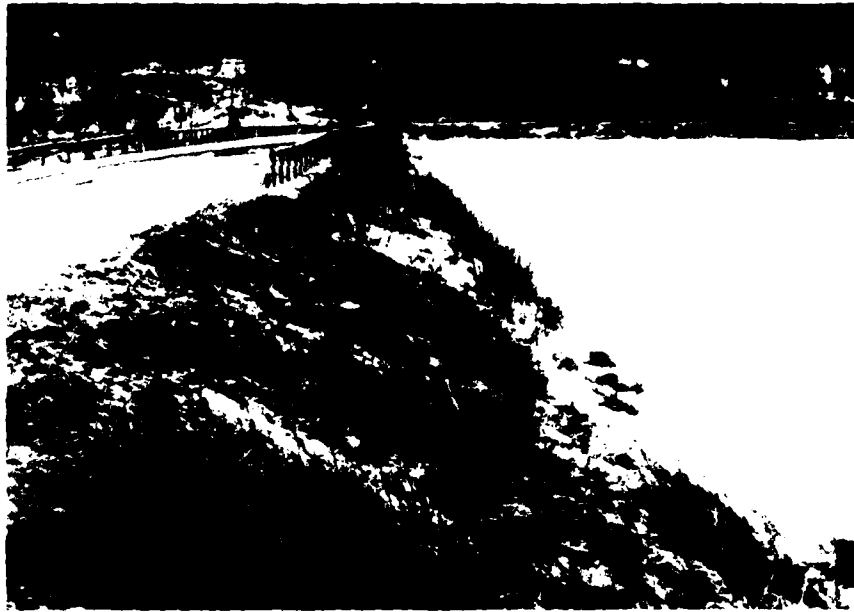
4. The upstream riprapped slope was covered with grass and brush, and scattered 3 inch diameter tree or brush stumps were observed between the riprap (See Photos No. 4 and 6). These stumps had been cut off within the past several years.

PHOTO #4: Overview of upstream face of dam

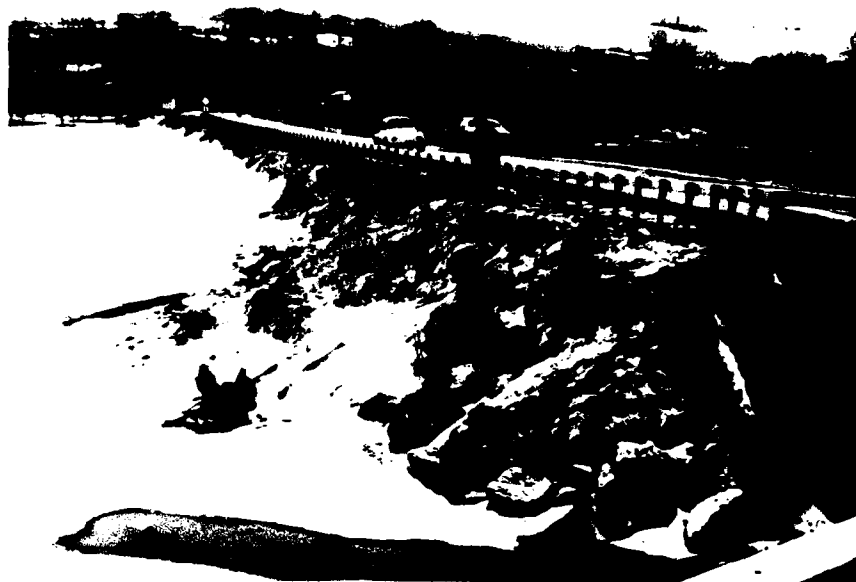
PHOTO #6: Upstream face of dam

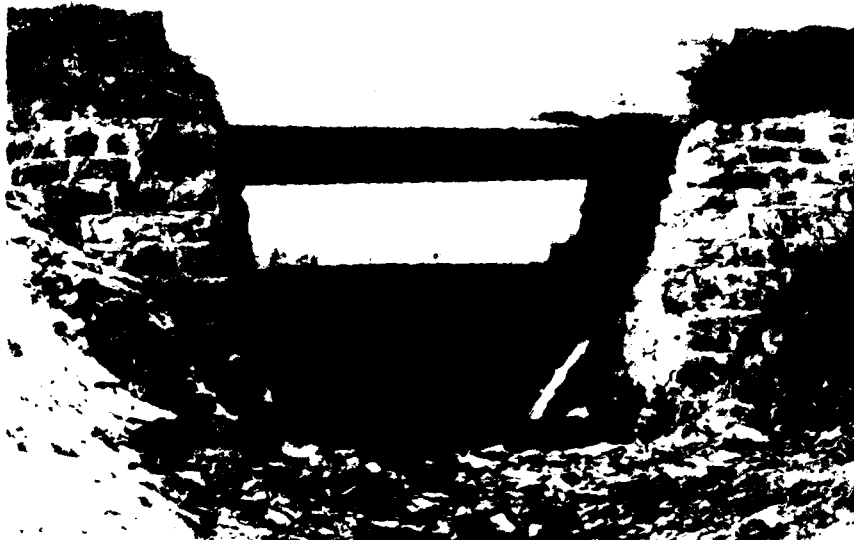
PHOTO #8: Emergency spillway
looking toward impoundment
